Fracture Propagation in Multi-Piece Run Flats

Sebastian K. Karwaczynski

TARDEC (Submission To MTU in fulfillment of MEEM 6130), Warren, Michigan, 48397

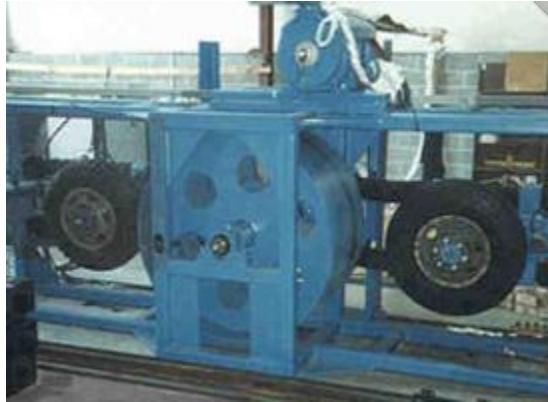
Figure 2. Typical fatigue rated testing machine

Testing of a run flat consists of testing in a laboratory and testing on a vehicle. When tested in a laboratory a fatigue rated testing machine is used as shown in Figure 2. The run flat is first mounted onto a rim (or wheel) and later mounted onto the test machine. The machine has the ability to apply load and various slip and camber angles to simulate “real world” conditions because it is unlikely that a vehicle has the wheels set to exactly 0° . Though for this type of comparison testing the wheel angles are set to 0° . Appropriate loads are applied to the run flat that replicate real world scenarios
